ILDIKO KERTESZ BRINAS  
NARCIS IONEL REBEDEA  
ILIE LUCIAN OLTEAN

## Bucket wheel excavator cutting tooth stress and deformation analysis during operation using Finite Elements Method (FEM)

*In the case of bucket wheel excavators, the cutting process is influenced by the forces opposing the working elements and cutting tools. These forces determine the choice of machines and their parameters as well as the operating method [1, 2]. Studies conducted on the failure causes of mechanical parts show that the cutting and loading systems cause the highest rate of failure – about 32% of all recorded mechanical failures [3]. In this paper, we will use the Finite Element Method (FEM) to analyze the deformations and stresses acting on the cutting teeth mounted on the rotor of BWEs. For this, SolidWorks® software was used, both as a CAD tool to design the teeth as well as to model and simulate the phenomena.*

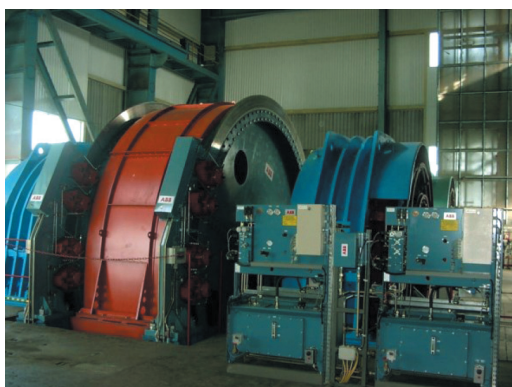
Both hydraulic units of the control and power supply unit of the break are located at the level of the hoisting machine. Figure 1 presents the view of the machine in the (S) section after modernization.

Fig. 1. View of hoisting machine in section (S) of R-II shaft after modernization in 2004 [1]

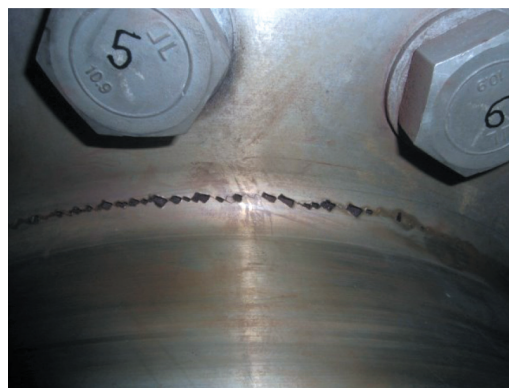
A crack as well as chips of the material in some places were visible along about half of the circumference of the shaft. The nature of the damage indicated fatigue crack (Figs. 2 and 3).

Fig. 2. Cracks in circumference with crushing [1]

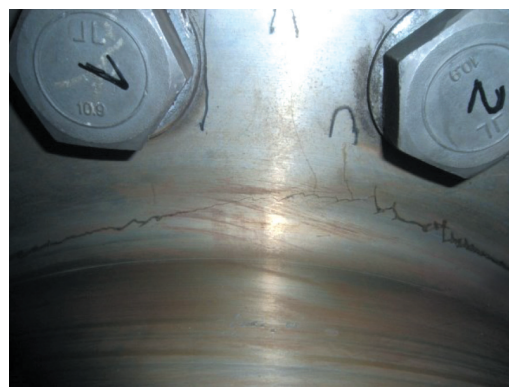
Fig. 3. Cracks on circumference and radial cracks [1]
